# Update

FEBRUARY 1999

## BPAT Process Activated for Hurricane Georges in Puerto Rico.

## BPAT Process Activated for Hurricane Georges in the Gulf Coast

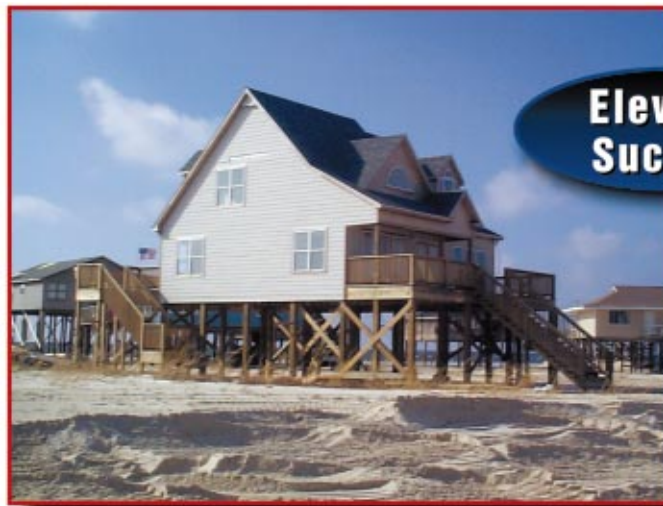
Elevated  
Success

The PFAT flew along the coast from Navarre, FL, to Gulfport, MI. From the air, it appeared that coastal damages were concentrated along the front row of houses along the Gulf of Mexico shoreline. As shown in the photograph above from Dauphin Island, elevated houses on deep pile foundations effectively withstood Hurricane Georges.

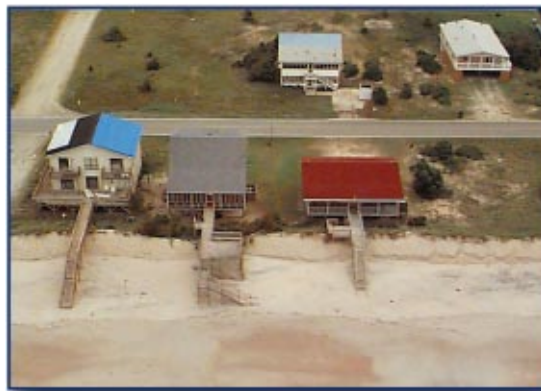
**After the storm passed, FEMA helped homeowners reduce further damage by providing tarps that could be secured over damaged roofs (note blue tarp on house at left).**

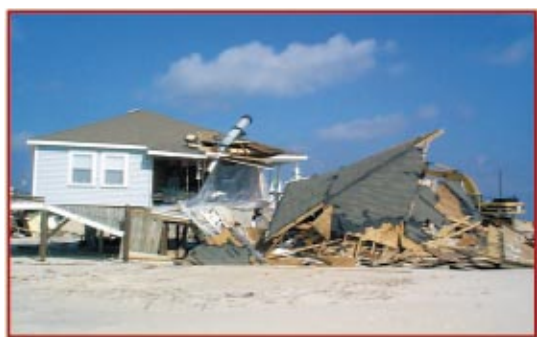
**Dauphin Island, Alabama** – The BPAT observed widespread damage on the western end of the island that included considerable overwash of floodwaters and sand. Several houses were washed off their foundations. Some of these houses floated into others, causing major damage (see photograph above).

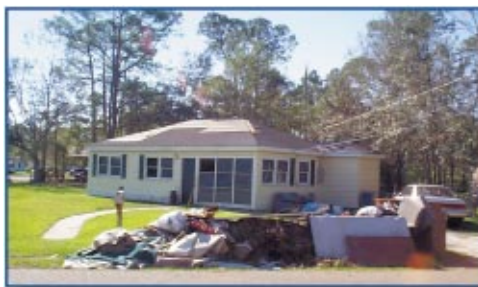
NFIP and local floodplain management requirements. The photograph left shows an example of an older, slab-on-grade house that flooded and also suffered damage to asphalt roof shingles.

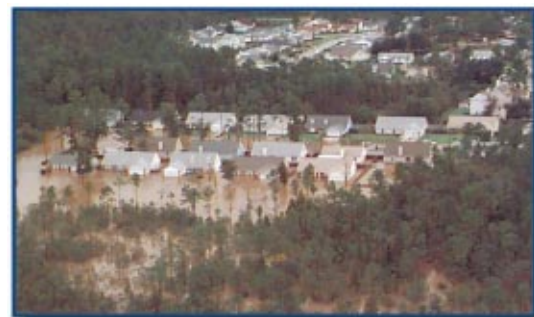
– The team assessed damage caused by riverine flood waters along the Shoal River that, in many cases, exceeded the Base Flood Elevation by several feet. One neighborhood (shown below) was outside the Special Flood Hazard Area but still suffered flood damage. The damage to these and other buildings demonstrates that structures adjacent to Special Flood Hazard Areas are still exposed to a residual risk of flooding.

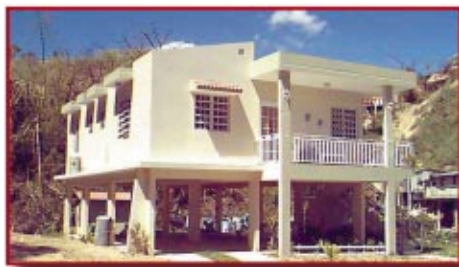
In general, reinforced concrete residential buildings with reinforced concrete roof systems performed extremely well during Hurricane Georges, suffering no structural damage (see the photograph above). A continuous load path from the roof system to the foundation was observed in these buildings.

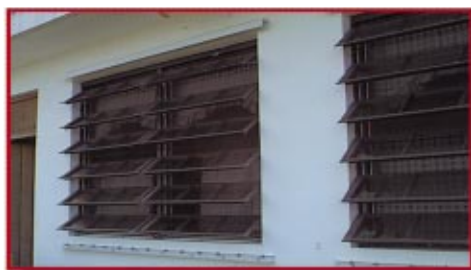
Many residential and commercial buildings were equipped with storm shutters of numerous designs and materials. Temporarily installed metal shutters were used with great success on concrete houses throughout the island. In the photograph above, the tracks used to anchor the metal shutters to the house can be seen immediately above and below the windows. The BPAT also observed permanently attached metal rolldown shutters. The small number of these systems inspected were found to have suffered no damage from the hurricane. In addition, the windows of some houses were successfully protected with wooden shutters.

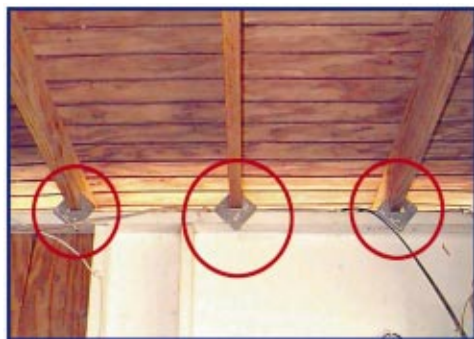
In support of repair efforts after Hurricane Marilyn in 1995 and Hurricane Hortense in 1996, FEMA provided hurricane clips and shutters to homeowners on the island of Culebra through the Hazard Mitigation Grant Program. Many of these clips and shutters were observed by the BPAT in its visits to houses on the island. The photograph on the right was taken in a house that was retrofitted with hurricane clips. This house suffered no structural damage during Hurricane Georges.

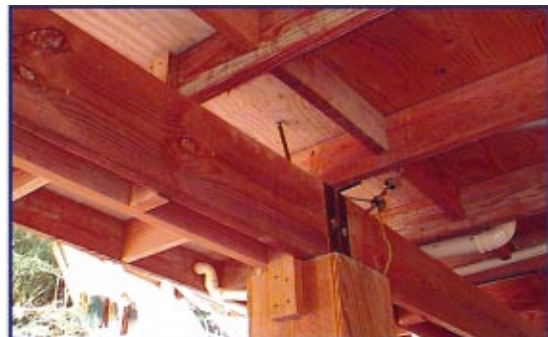
Another successful mitigation practice observed on the island of Culebra was the provision of a continuous load path – from the roof to the foundation – in wood-frame houses constructed since Hurricane Marilyn. In addition, some wood-frame houses that lacked a complete

load path still included adequate connections between the floor system and the foundation (see photo above).
